**Contract # 34328**

## **Reserve Study**

### **Casa Prima COA**

1859 Shore Dr S, South Pasadena, Florida 33707

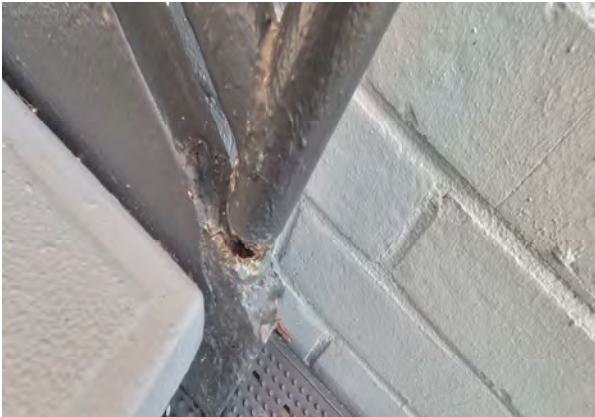
43 Deteriorated Weld at Front Left Staircase

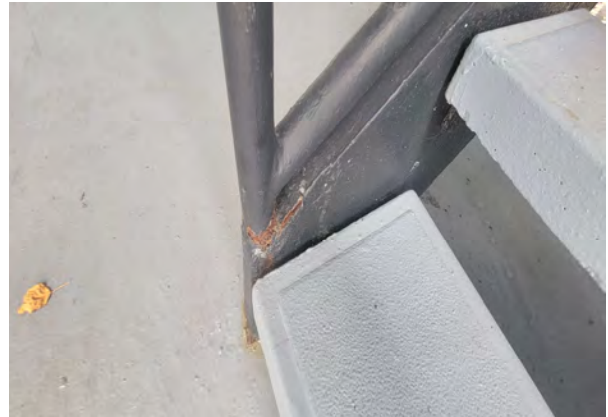
44 Deteriorated Weld at Front Left Staircase

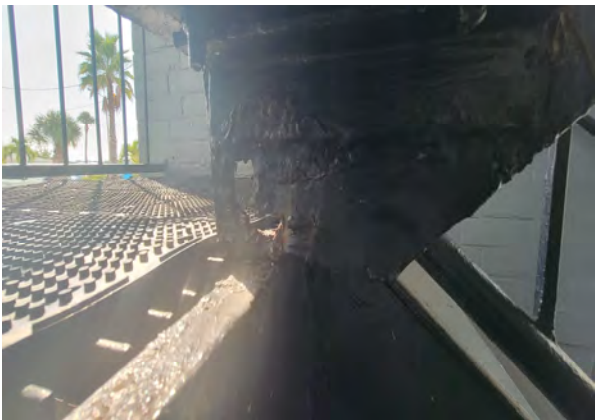
45 Deteriorated Weld at Front Left Staircase

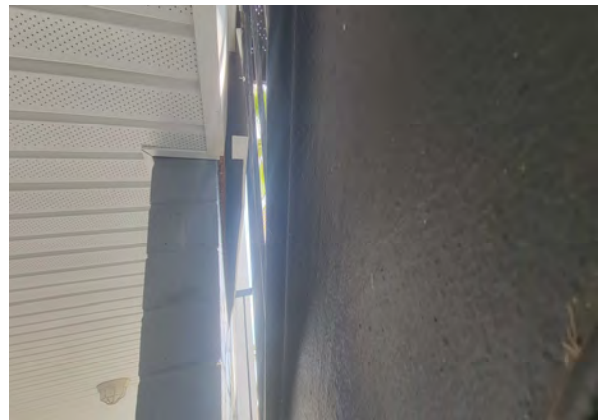
46 Loose Fascia Front Left Staircase

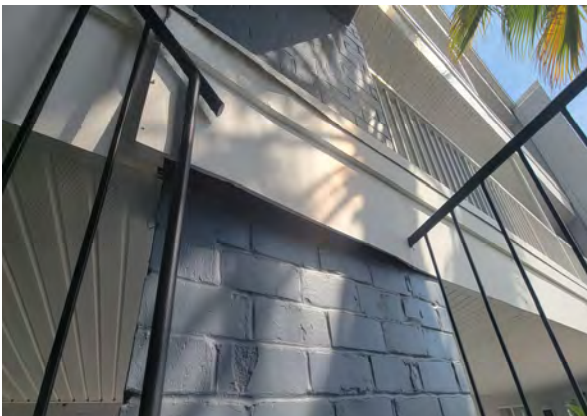
47 Loose Fascia Front Left Staircase
