COMMERCIAL WINDSTORM MITIGATION REPORT

Casa Prima Apartments

COMMERCIAL WINDSTORM MITIGATION REPORT (OIR-B1-1802)

Casa Prima Apartments
1859 Shore Dr S, Units 101-310
South Pasadena, FL 33707

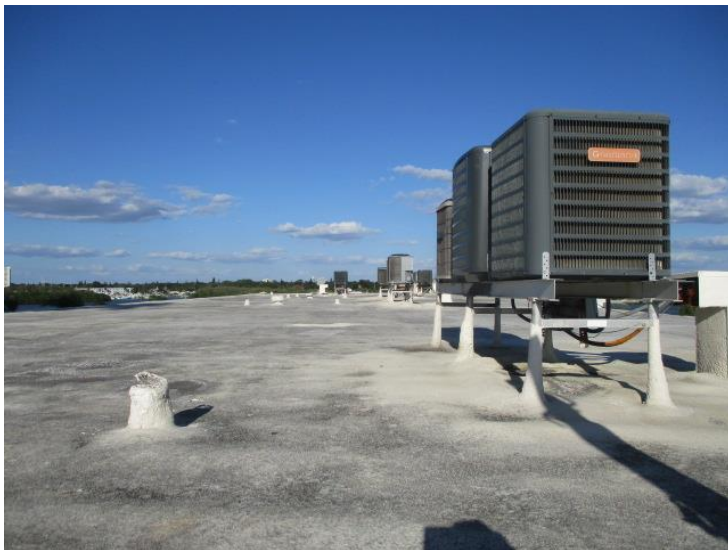
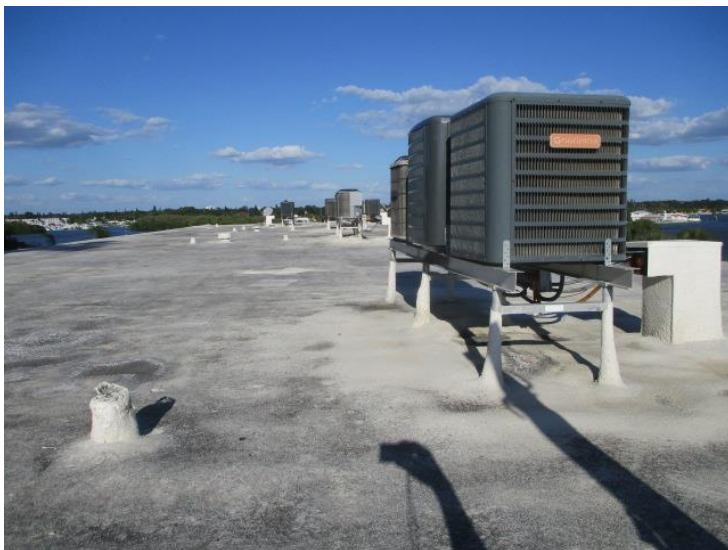
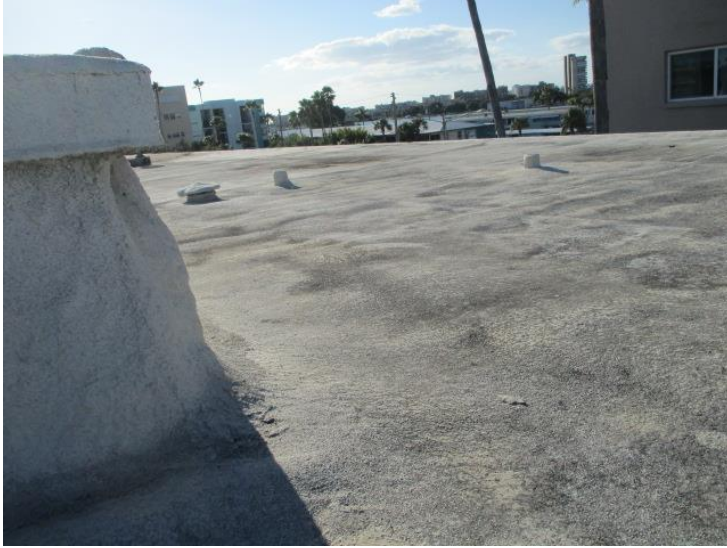
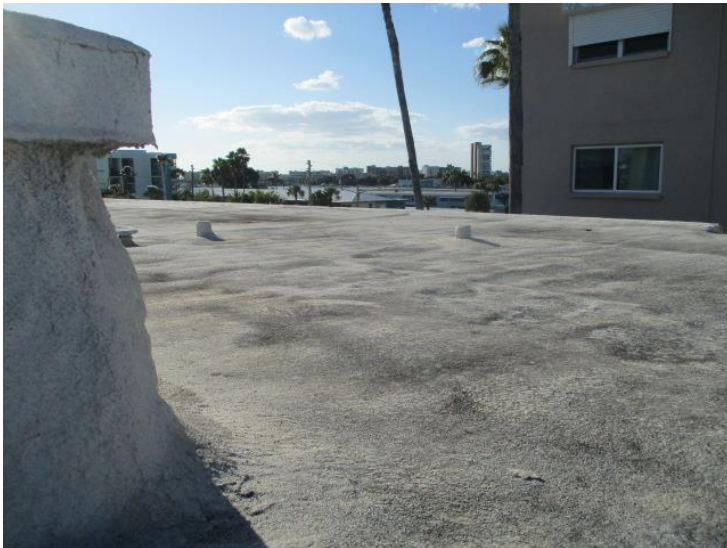
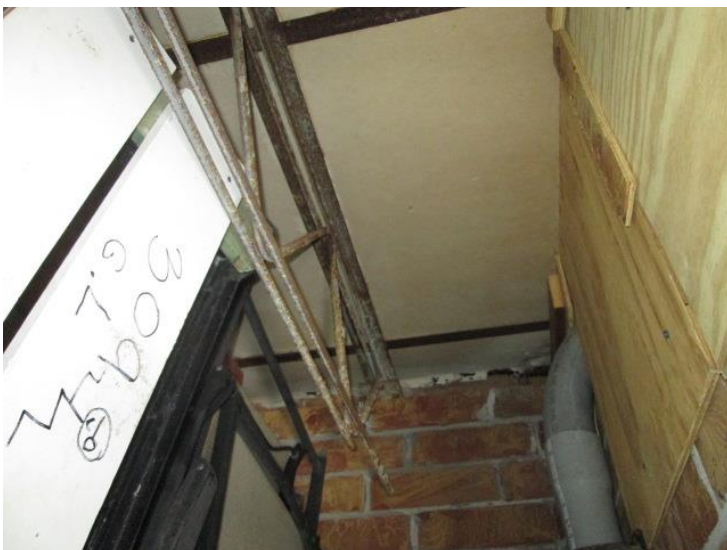
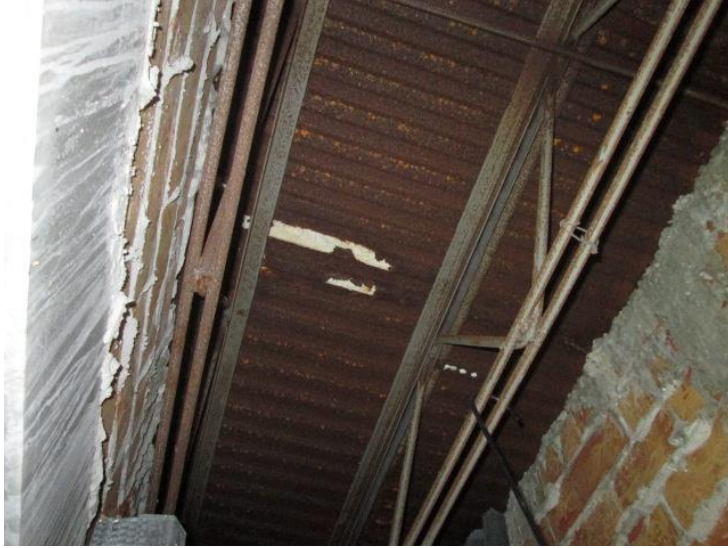
Roof Construction

3. **Roof Deck Attachment:** **Other**
Comments: Inspection verified a roof deck composed of lightweight concrete gypsum panels supported by steel bar joists.

4. **Roof to Wall Attachment:** **Structural**
Comments: Inspection verified a roof-wall connection composed of steel bar joists structurally connected to the wall/support system.

5. **Roof Geometry:** **Flat Roof**
Comments: Inspection verified a flat roof shape.

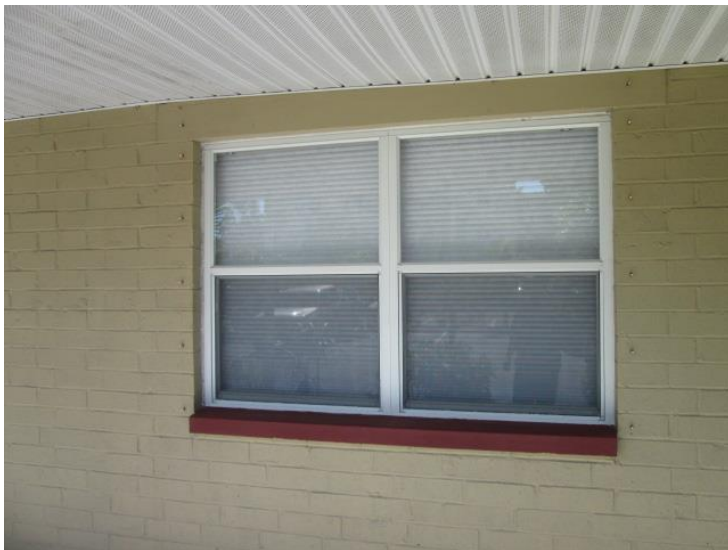
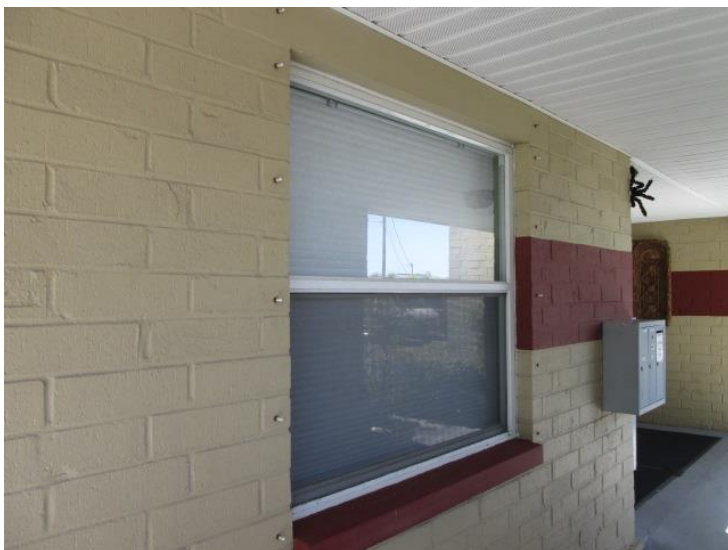
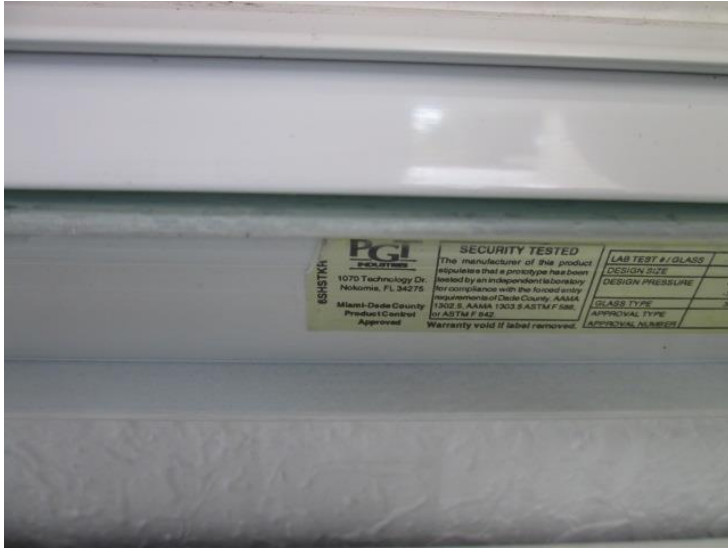
Opening Protection

7. **Opening Protection:** **Exterior Openings Cyclic Pressure & 9-lb Large Missile**
Comments: Inspection verified all windows and sliding glass doors are protected with laminated large missile impact rated glass or metal shutters.
